UNDERWATER BRIDGE INSPECTION REPORT

STRUCTURE NO. 69623

ST. LOUIS RIVER

MINNESOTA DEPARTMENT OF TRANSPORTATION
UNDERWATER BRIDGE INSPECTION

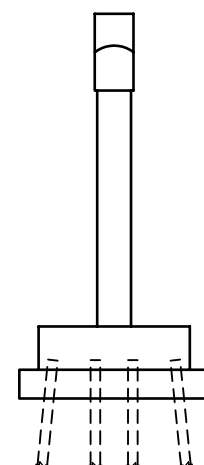
TYPICAL END VIEW OF PIERS

1. The channel bottom consisted of soft silt with 1.5 to 2 feet of probe rod penetration and riprap at the upstream nose of Pier 1.
2. The concrete of Pier 1 was in good and sound condition.
3. A heavy accumulation of timber debris was observed at the upstream nose of Pier 1 extending from the channel bottom to 6 feet above the waterline. The accumulation extended approximately 20 feet into the channel and from about 20 feet upstream of the nose to halfway down the east side of the pier, with a 2-foot-diameter log extending along the west side of the pier.
4. A 2-foot-diameter log was observed along the west side of Pier 1.

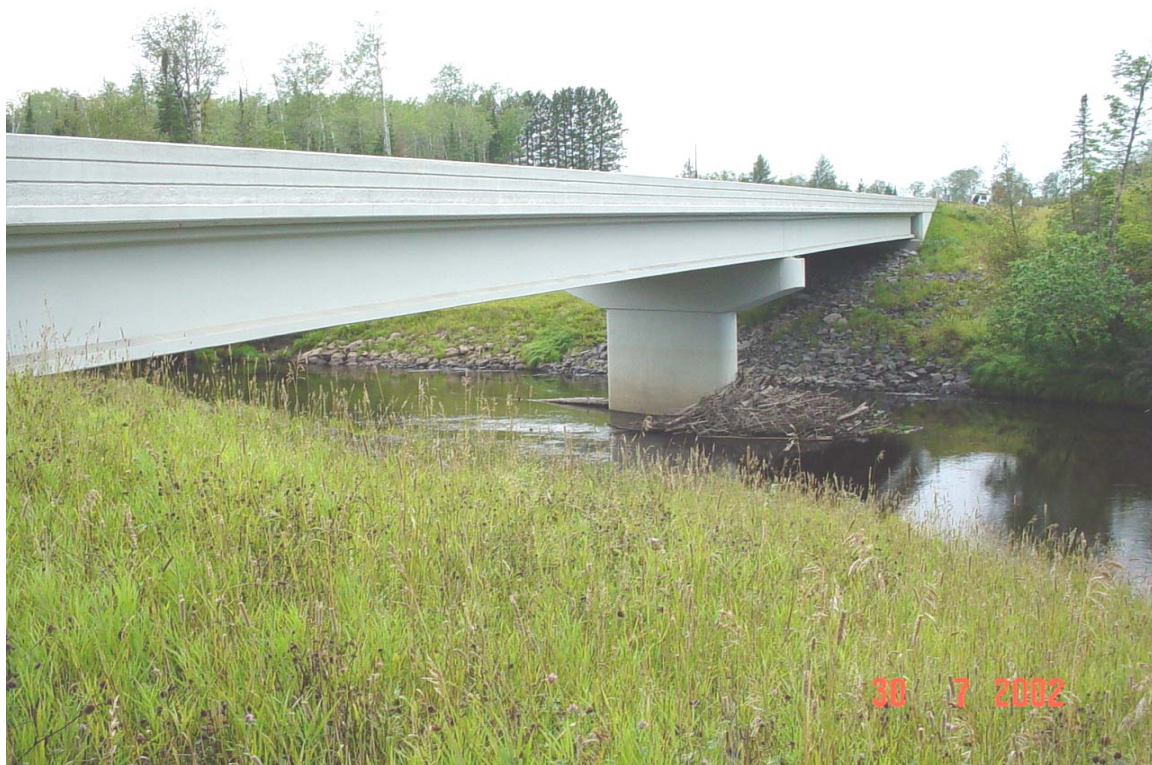
Photograph 1. Overall View of Structure, Looking Southwest.
